Notes and Curiosities on Some WJ-8718/MFPs Partially Made in China

by Paolo Viappiani Via Magenta 32 54033 Carrara, Italy pviappiani@tin.it

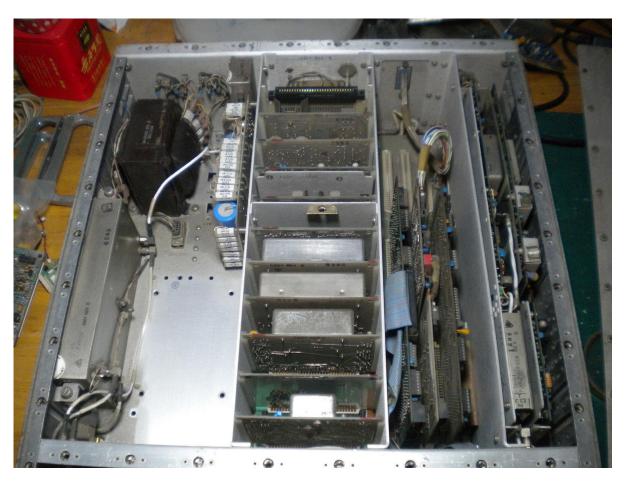
Before considering the "Chinese" MFP front panel in more details, it's interesting to give a closer look at the inner of the radio and at its rear panel. The Figures 6 and 7 show the inner of the WJ-5JK chassis, and from them it seems that there are no differences at all from the stock WJ-8718 chassis; everything seems to be original and made in the U.S.A.

Figure 6: Inner of the WJ-5JK chassis (please note that the *Preselector* unit is not present).

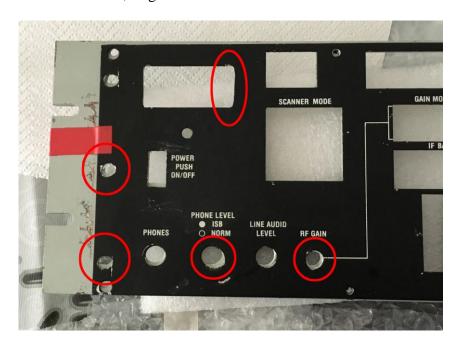
The first observations about that front panel confirmed the impressions I had from looking at the previous WJ-5JKs shots (that I had saved into a folder of my PC). Apart from the physical differences among the key sizes, colors and location, it is evident that the "Chinese" MFP front panel was built with less accuracy compared to the original unit; please give a look at the *S-Meter* cutout (very imprecise especially on its right side) and at the *Phone Level* and *RF Gain* potentiometer shaft holes etc., Figure 10.

Figure 10: The many inaccuracies found in the thin black metal sheet cutouts of the WJ-5JK front panel.

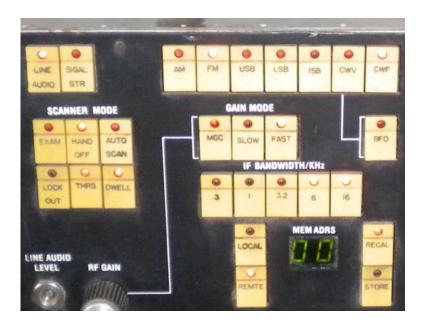
Among the other misprints that were found on the engraved front push-button covers, I already quoted some of them on my FB post of Ref. [3]: please notice the wrong writings "SIGAL STR" (instead of "SIGNAL STR"), "REMTE" (instead of "REMOTE"), "RECAL" (instead of "RECALL") in Figure 14.

Figure 14: Some misprints that were found on the engraved push-button covers lettering.

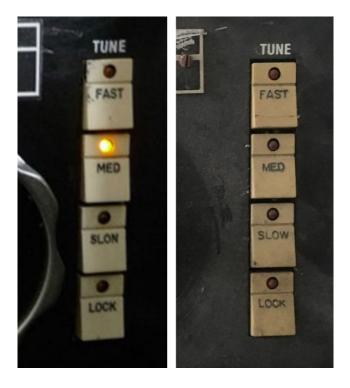
Almost surprisingly, I didn't find the typo "SLON" (instead of "SLOW", that I had previously noticed on the *Tune Rate* pushbutton of other WJ-5JKs, Ref. [3]) in the MFP front panel that I recently received, look at Figure 15 (Left/Right).

Figure 15: In the left picture a pushbutton with the typo "SLON" is shown, while in the right one it appears the same key with the proper writing.

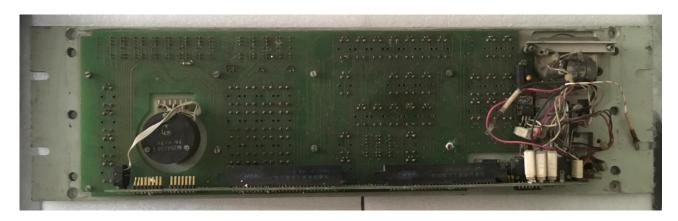
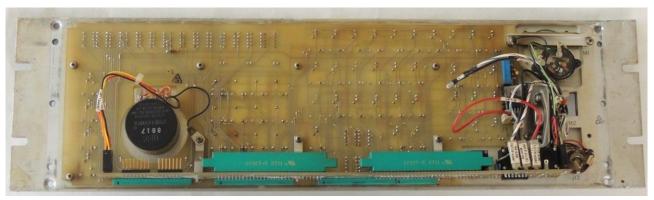
The printed circuit board that sits behind the front metal plate is similar (but not identical) to the stock WJ-8718A/MFP one. From the comparison of Figures 16 (the WJ-5JK PCB is shown in the top, the stock WJ-8718A/MFP PCB in the bottom), you can notice some differences both in the position of the switches and of the 7-segment LEDs, and also noticeable are the differences due to the use of alternate-type pushbutton switches. Almost identical are the circuits in the vicinity of the RF/Audio meter instead, Figures 17 (A/B).

Figures 16 (A/B): The WJ-5JK front panel PCB is shown in the top, in the bottom the stock WJ-8718A/MFP appears.

Please notice that in my humble opinion the differences in the PCB tracks (as well as in the size and position of the front pushbuttons of the WJ-5JK receiver are mainly due to the choice of different types of tactile switches, we'll talk again later about this topic.

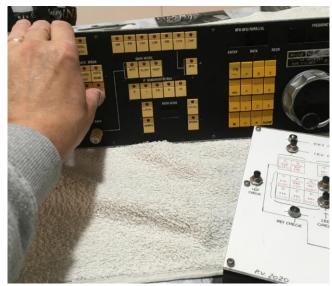
Some problems (and this was not much surprising to me, based on my past experiences with some stock WJ-8718A/MFP receivers that I found in Turkey in the past years [7]) involve many of the push-button switches that are mounted on the front panel PCB and that always show some undue contact resistance (instead of a secure and reliable momentary short when pressed and a total contact insulation when released).

The presence of such problems was confirmed by the use of my MFP front panel tester, in which a green light appears when a switch check is successful (an example is shown in Figure 33) or remains off (or dimly lit only) if the test fails, look at Figures 34 and 35.

Figure 34: A failed switch check.

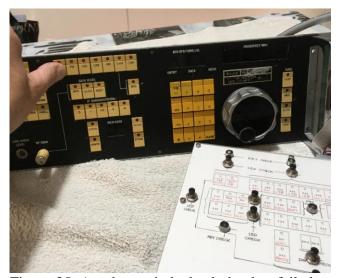
Figure 35: Another switch check that has failed.

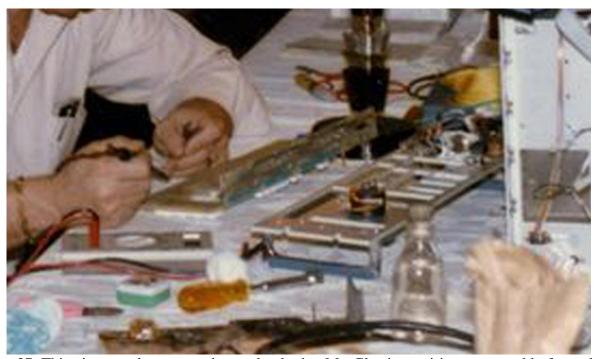
So, re-reading in the light of this bad issue the story of Mr. Bob Glaz (who is said to have replaced some *Tantalum* capacitors on the WJ-8718A/MFP that had been sent to China [Ref. 2]), I started thinking that he didn't replace *Tantalum* capacitors, he tried to fix the pushbutton failures instead. A sort of confirmation comes from attentively looking at Figures 36 and 37.

Figure 37: This picture enlargement shows clearly that Mr. Glaz is repairing an assembly formed by the Type 794309 MFP-A1A2 *Front Panel Switch* board and by the Type 794310 MFP-A1 *Front Panel Switch/Encode* board. Please notice that in both those boards there are no *Tantalum* capacitors!
