Notes and Curiosities on Some WJ-8718/MFPs Partially Made in China

by Paolo Viappiani Via Magenta 32 54033 Carrara, Italy pviappiani@tin.it

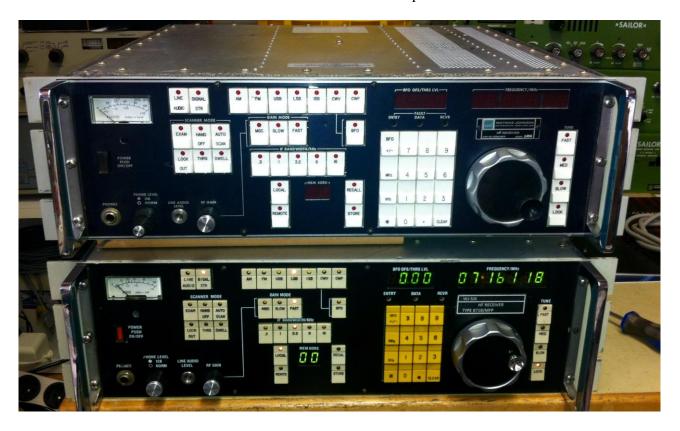
Figure 1: A stock WJ-8718A/MFP superimposed to its "Chinese" WJ-5JK version.

Apart from the green-colored 7-segment LED displays, the first thing that catches the eye is the difference in size and position (and also in the color used for the numeric keypad buttons) of the front keys of the two receivers.

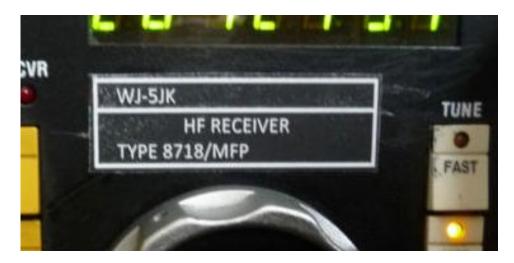
Figure 2: A somewhat restored WJ-5JK front tag.

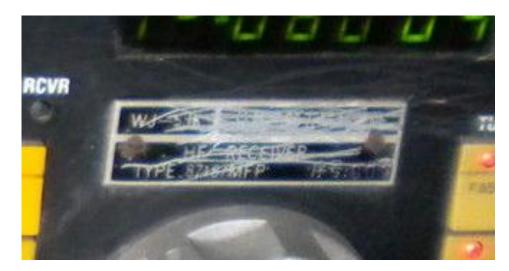
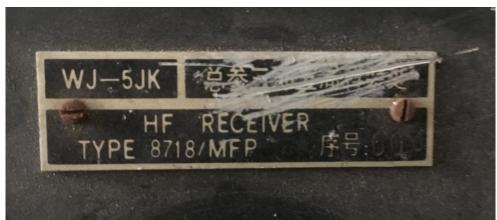
Figures 3 and 4: Two non-restored examples of WJ-5JK Front Tags

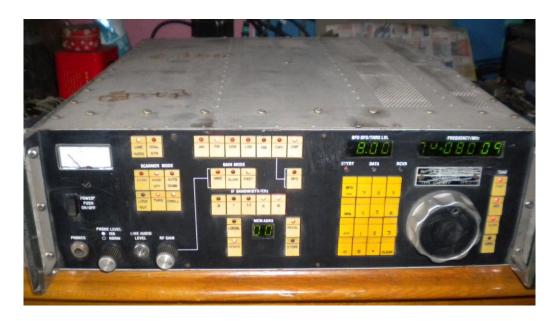
Figure 5: Another WJ-5JK unit.

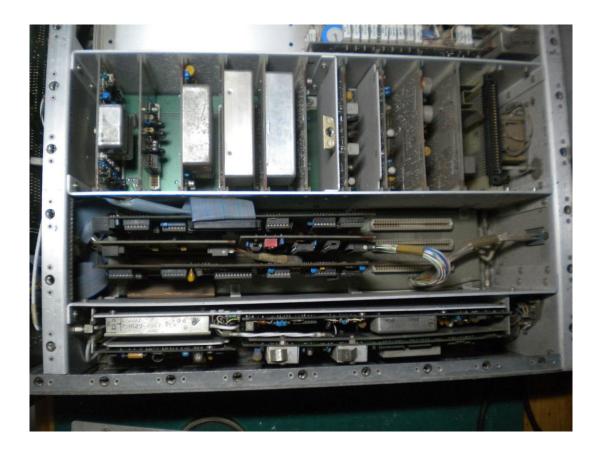
Figure 7: Details of the A4 (*IF section*), A6 (*I/O section*) and A5 (*Synthesizer section*) of a WJ-5JK radio. Please notice that all the "A4" cards (including the optional ISB 791598-1) are present, as also are the 796002 PRE-A2 *Preselector Decode* card, the 796075 *GPIB-IEEE488-A3 I/O Interface* card (in the mid row of the A6 Motherboard), the 794308-2 *MFP-A3 IF Interface* card and the 794275-X *MFP-A4 Synthesizer Interface/Memory* card in the 1st and 3rd A6 row. Also the A5 Synthesizer section seems to be original and complete.

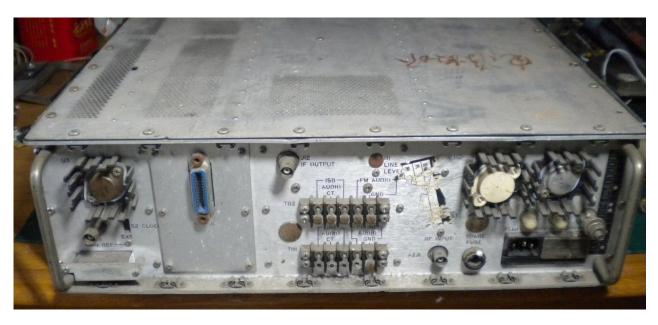
Figure 8: The rear panel of a WJ-5JK receiver is identical to the stock WJ-8718A/MFP one and seems to have been Factory built in the U.S.A.

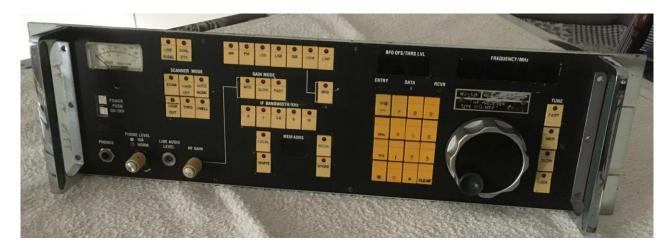
Figure 9: The WJ-5JK MFP front panel as received from my Chinese friend. (the two little beige pot knobs are temporary replacements, I already have the larger black knobs at hand and I'll replace them ASAP).

The first observations about that front panel confirmed the impressions I had from looking at the previous WJ-5JKs shots (that I had saved into a folder of my PC). Apart from the physical differences among the key sizes, colors and location, it is evident that the "Chinese" MFP front panel was built with less accuracy compared to the original unit; please give a look at the *S-Meter* cutout (very imprecise especially on its right side) and at the *Phone Level* and *RF Gain* potentiometer shaft holes etc., Figure 10.

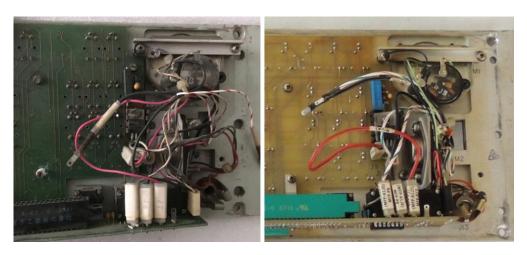
Figures 17: Comparison between the PCB sections near the meter (WJ-5JK at left, WJ-8718A/MFP at right); both the circuits are substantially identical.

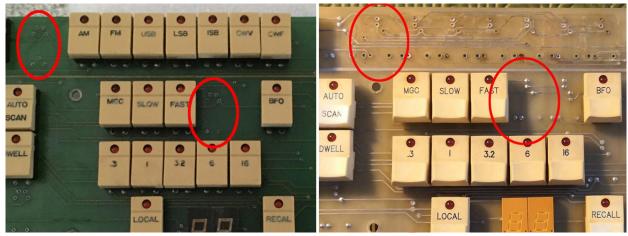
Figure 18: Comparison between the front PCB tracks on the front panel assembly of the WJ-5JK receiver (left picture) and of the stock WJ-8718A/MFP (right picture).

Please notice that in my humble opinion the differences in the PCB tracks (as well as in the size and position of the front pushbuttons of the WJ-5JK receiver are mainly due to the choice of different types of tactile switches, we'll talk again later about this topic.

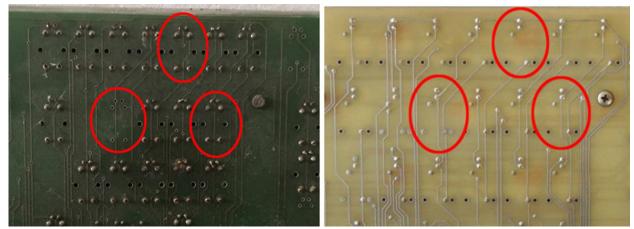
Figure 19: Comparison between the rear PCB tracks on the front panel assembly of the WJ-5JK receiver (left picture) and of the stock WJ-8718A/MFP (right picture).

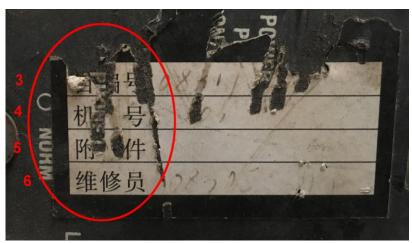
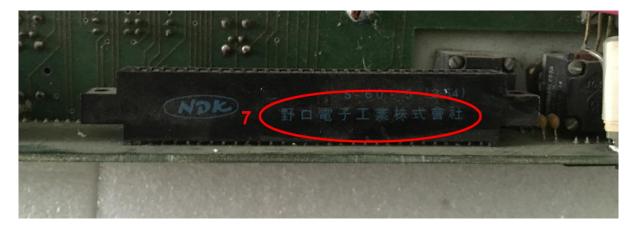
Figures 21, 22 and 23: Some Chinese writings found on the WJ-5JK front panel assembly.

Unfortunately those writings do not contain much information... it seems that the translations of the seven details mean:

- 1: The code name of the General Staff;
- 2: The unit serial number;
- 3: The self-number (?);
- 4: The machine number;
- 5: The part number;
- 6: The maintenance number;
- 7: Japan Noguchi Electronics Co., Ltd. Production (the Japanese manufacturer of the comb sockets).

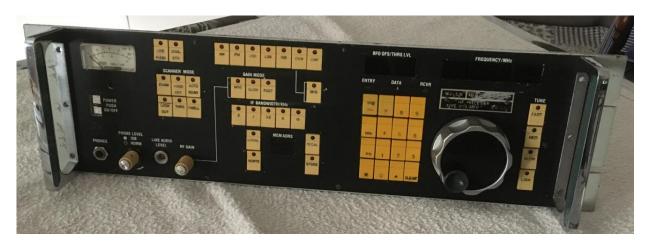
Figure 24: The partially restored Chinese MFP front panel. Please note that the two beige knobs in the left have been used temporarily only, the original ones are larger and black, look at Figure 1.

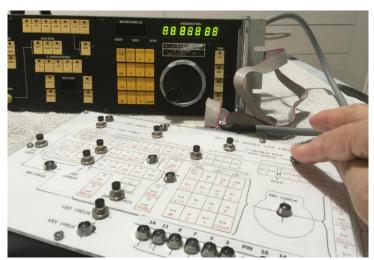
As shown in the Figures from 25 to 32, all the green-colored 7-segment displays and all the other red LEDs are OK and perform correctly without any problem.

Figure 25: Frequency Display check.

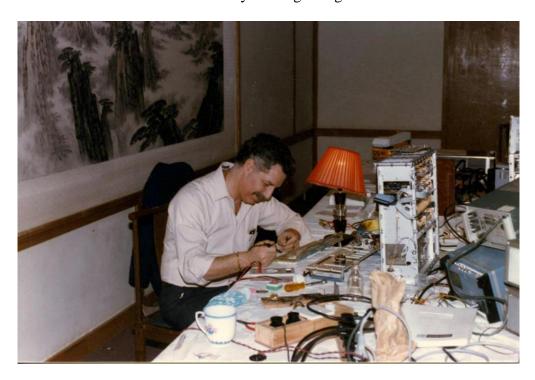
So, re-reading in the light of this bad issue the story of Mr. Bob Glaz (who is said to have replaced some *Tantalum* capacitors on the WJ-8718A/MFP that had been sent to China [Ref. 2]), I started thinking that he didn't replace *Tantalum* capacitors, he tried to fix the pushbutton failures instead. A sort of confirmation comes from attentively looking at Figures 36 and 37.

Figure 36: Mr. Bob Glaz is shown while repairing a front panel MFP PCB.

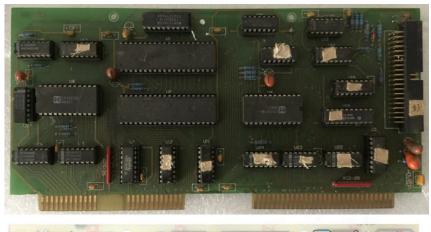
Beyond the above mentioned differences in the front panel assemblies, I found that also the WJ-5JK MFP-A1A1 *Front Panel Encode* card seems to have been built in China and it differs from the stock Type 796056-1, despite the majority of the components that were employed was the same of the stock card.

Figure 39: MFP-A1A1 cards front comparison.

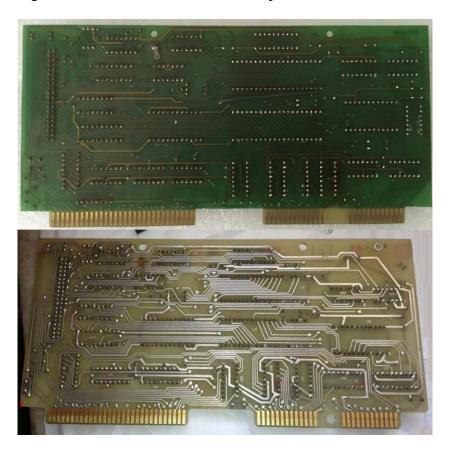
Figure 40: MFP-A1A1 cards rear comparison

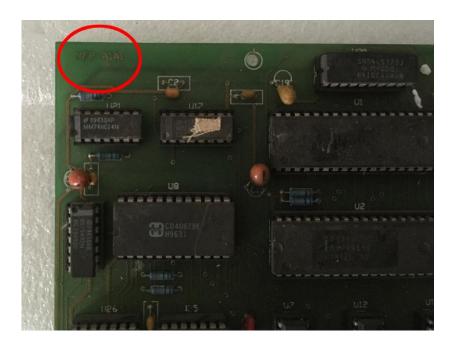
Please also notice that the only writing on the Chinese MFP-A1A1 card is just the one that appears in its front left corner, Figure 41.

Figure 41: The only writing that appears on the Chinese MFP-A1A1 cars is located on its top left side.
